Replacement of
Heating, Ventilation, Air Conditioning (HVAC) Units
In Apartments Located at 641 Fifth Avenue

Photo Essay

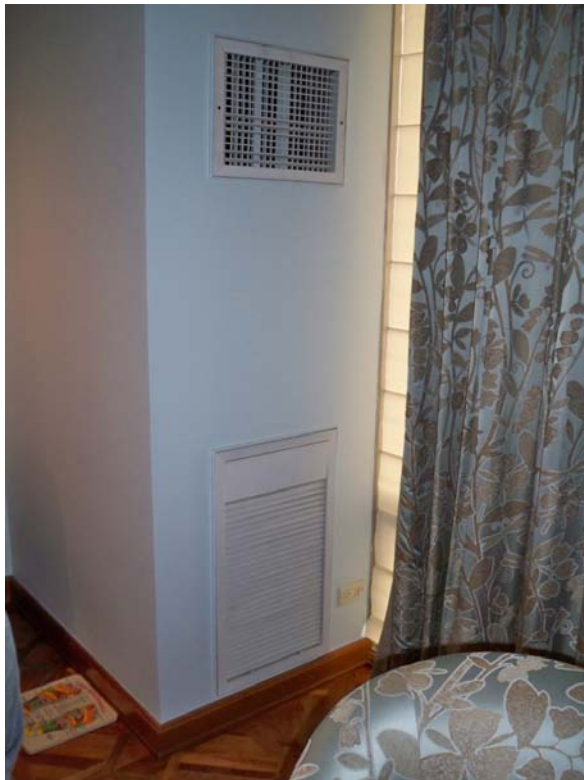
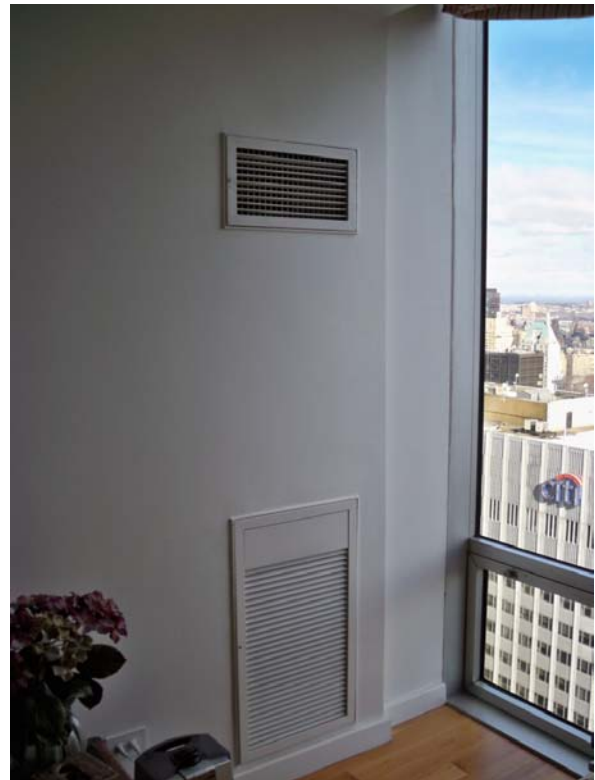
One fan motor draws air from the lower section of the unit, through a filter, blowing air across a heating coil and cooling coil, discharging the air from the upper section of the unit into the living space. The fan motor has a speed control knob (low-med-high).

The user can set the temperature selector scale from cold to hot. The selector sends a signal to two motorized valves (110 volt AC); which open or close to allow hot water to run through the hot water coil (for heat) or chilled water to run through the cooling coil (for A/C) as required to achieve the selector setting.

The photos below show typical, original HVAC units prior to any work.

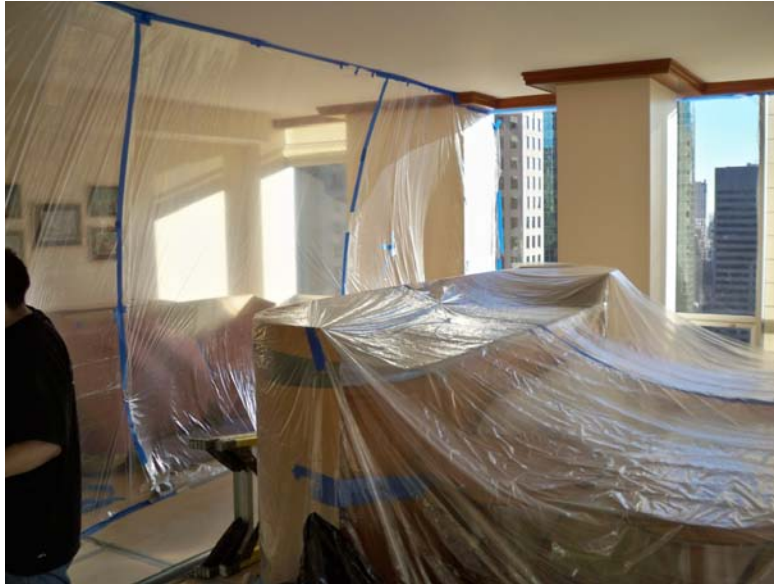
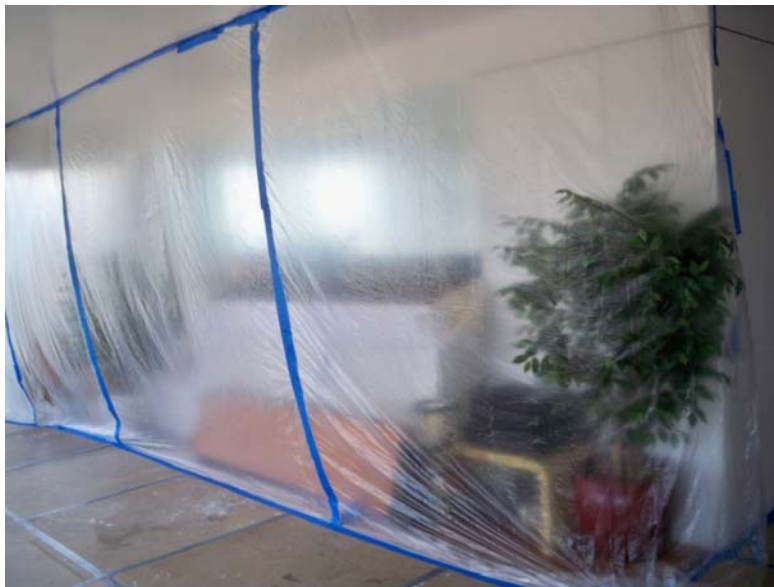
Protection – The contractor must protect the premises for the duration of the project.

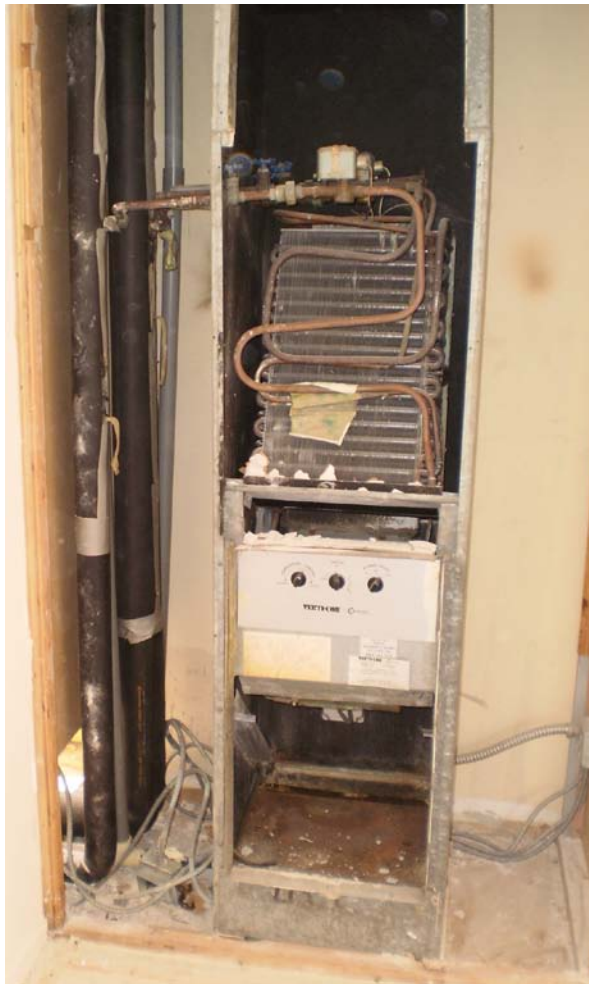
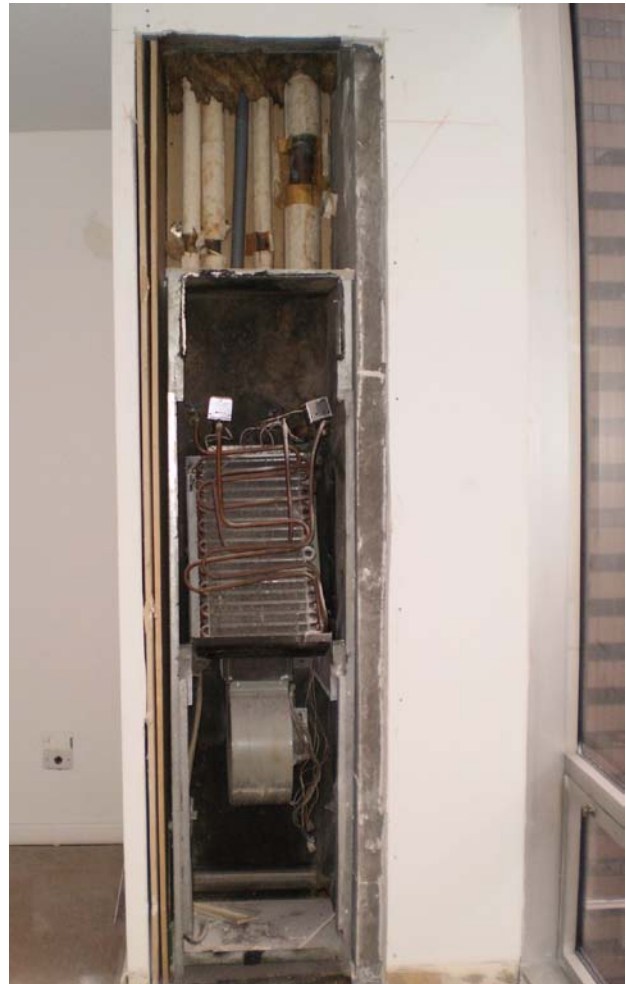
Demolition – Once the risers are drained, it is safe to cut the existing HVAC unit out of the wall.

In some instances the risers are located on the left side of the HVAC unit (see below left photo) and in some instances the risers are located behind the HVAC unit (see below right photo).

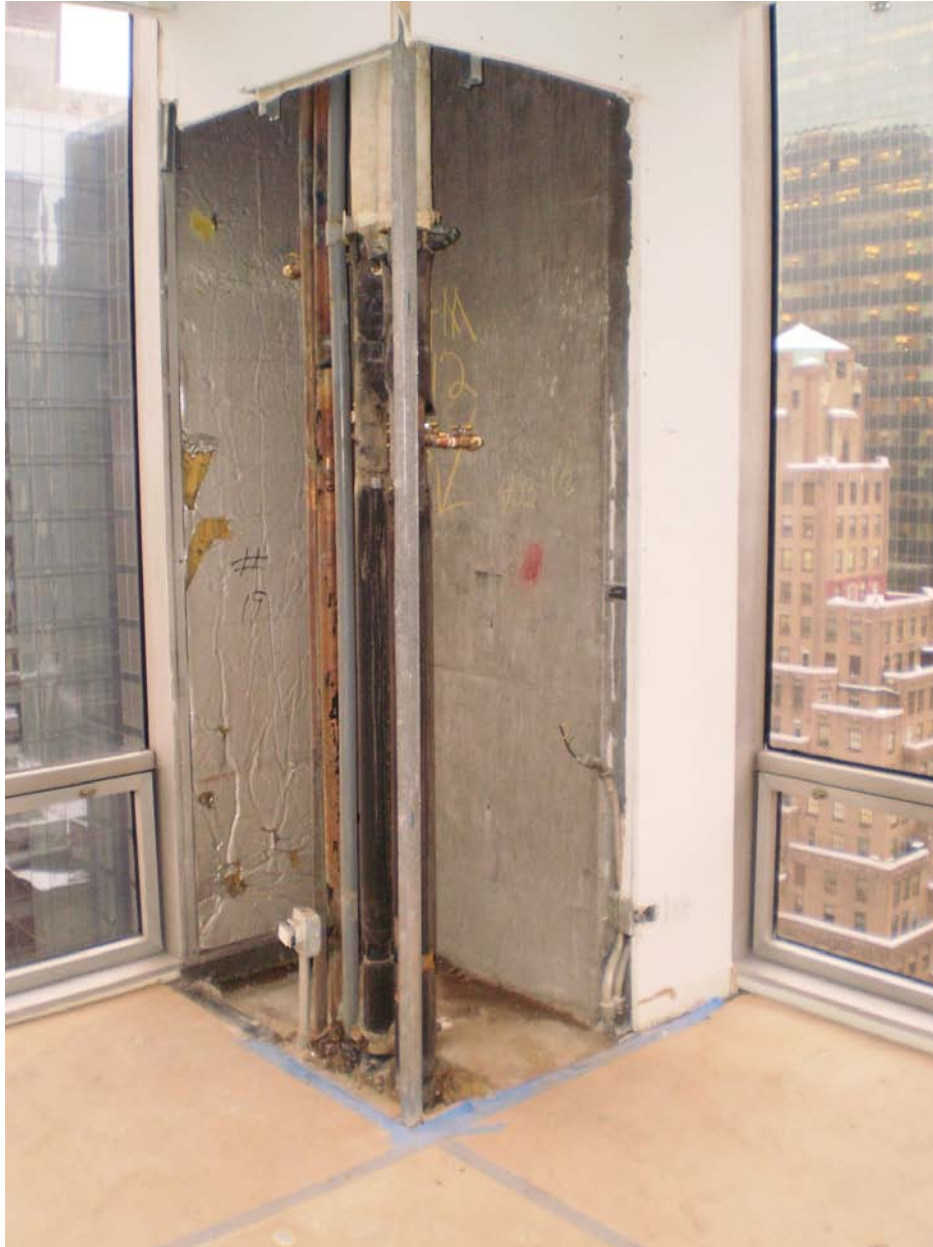
Installation of New Shut-Off Valves – Once the unit is cut out of the wall and removed; new shut-off valves are installed (four/unit). The photo below shows a corner location where two HVAC units were located.

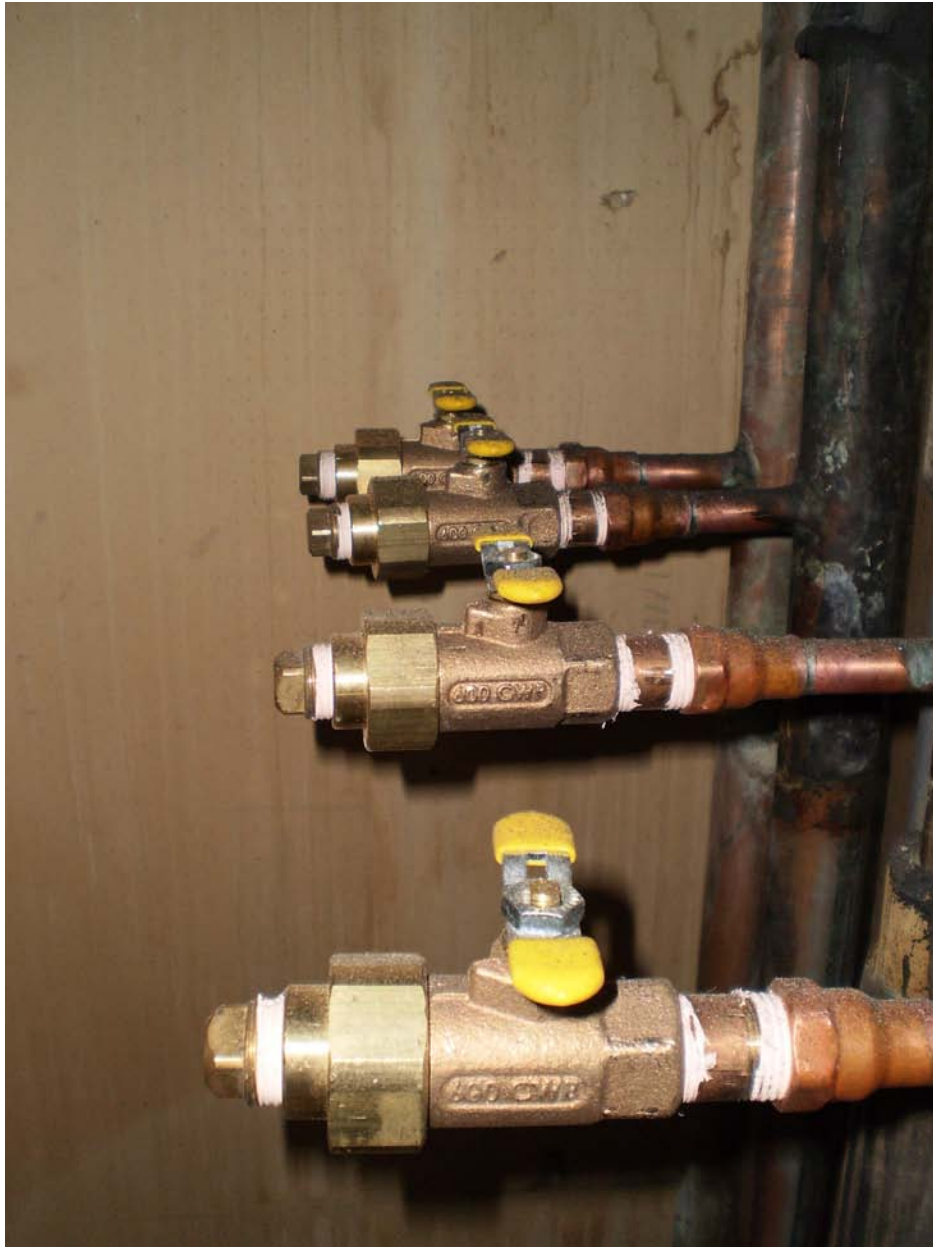
The photo below shows a close-up of new shut-off valves. Each HVAC unit requires four shut-off valves (hot water supply, hot water return, chilled water supply, chilled water return). Once the new shut-off valves are installed, a minimum of two staff members must supervise the re-filling of the risers the valve installation work must be checked for leaks.

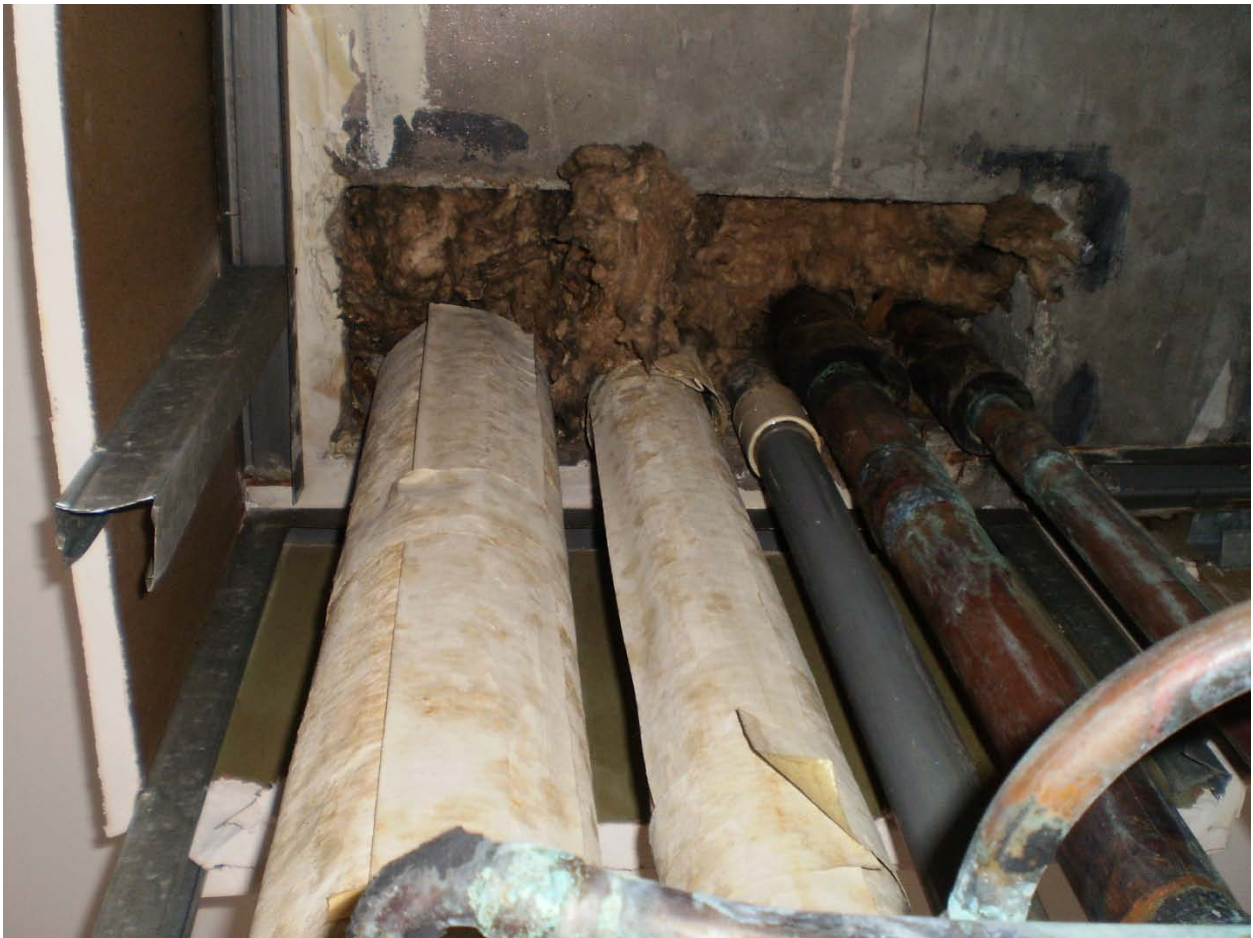
The photo below, looking up to the ceiling slab, shows old pipe insulation (white in color) and old fire stopping around the risers where they penetrate the ceiling slab (floor of the above apartment). As you can see, the risers in the right side of the photo didn't even have insulation.

Fire stopping and new insulation of all risers and supply lines – The contractor must remove any wet or otherwise damaged fire stopping and replace, or add additional UL rated materials to seal all surrounding wall openings and slab penetrations from the ceiling above and from the floor below.

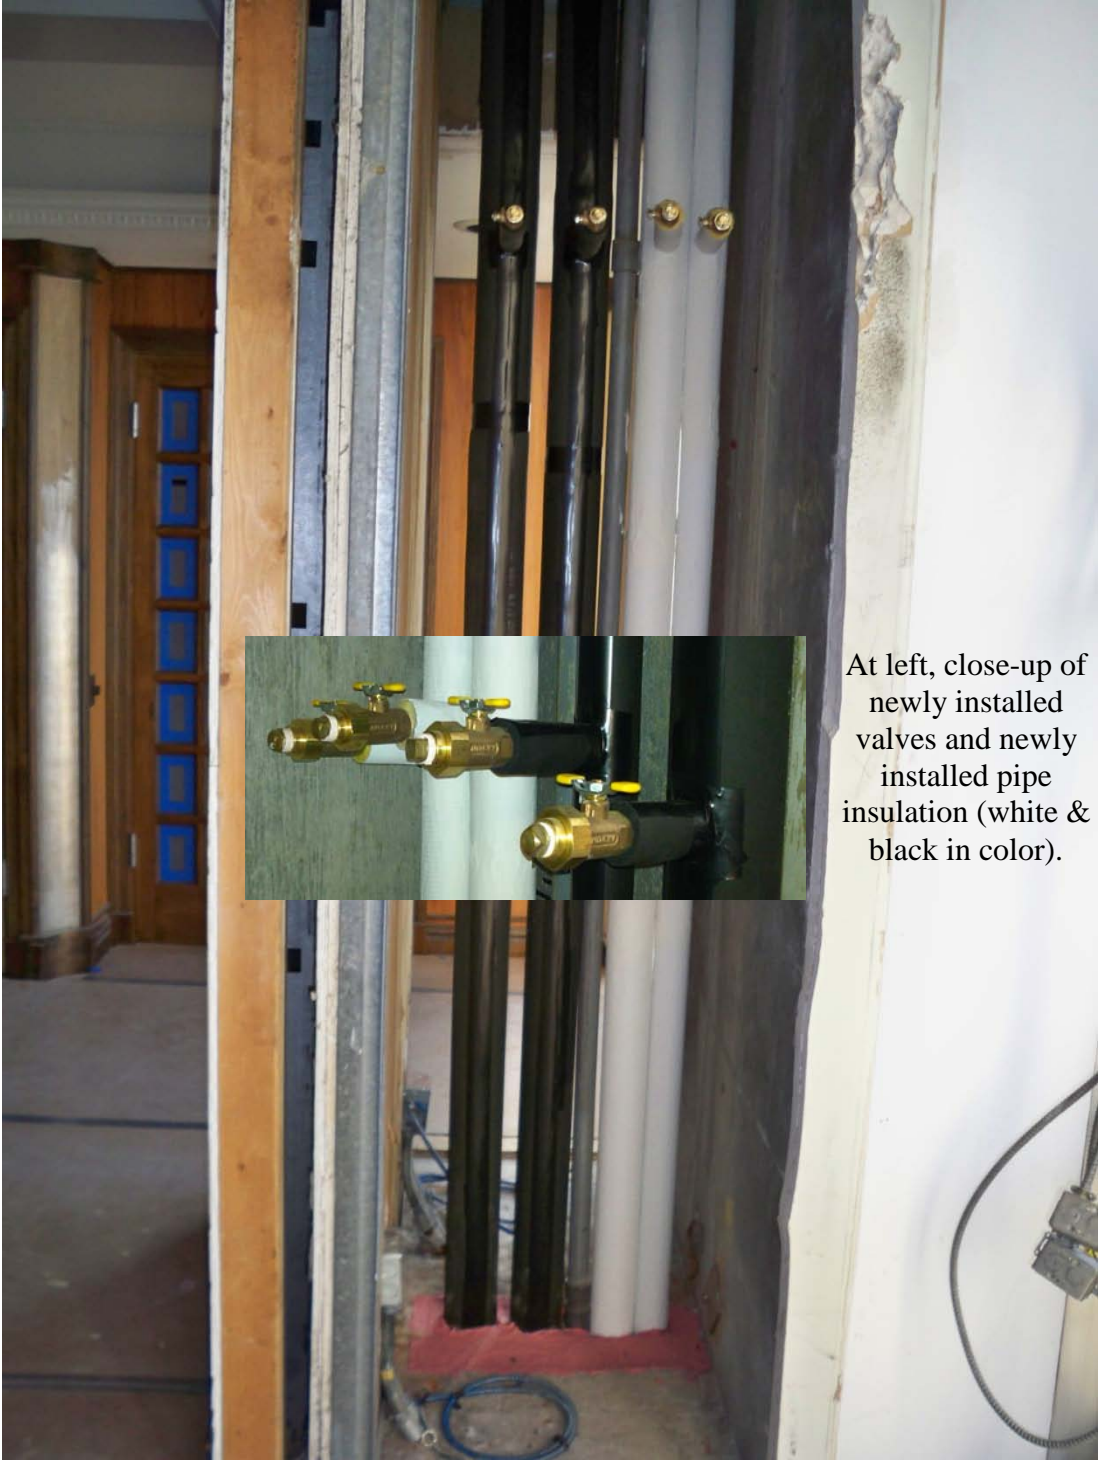
For energy saving purposes, but also to prevent condensation problems from sweating pipes, all old insulation is removed and new insulation is installed. The photo below shows new fire stopping on the floor (pink in color) and new pipe insulation (black and white, in color).

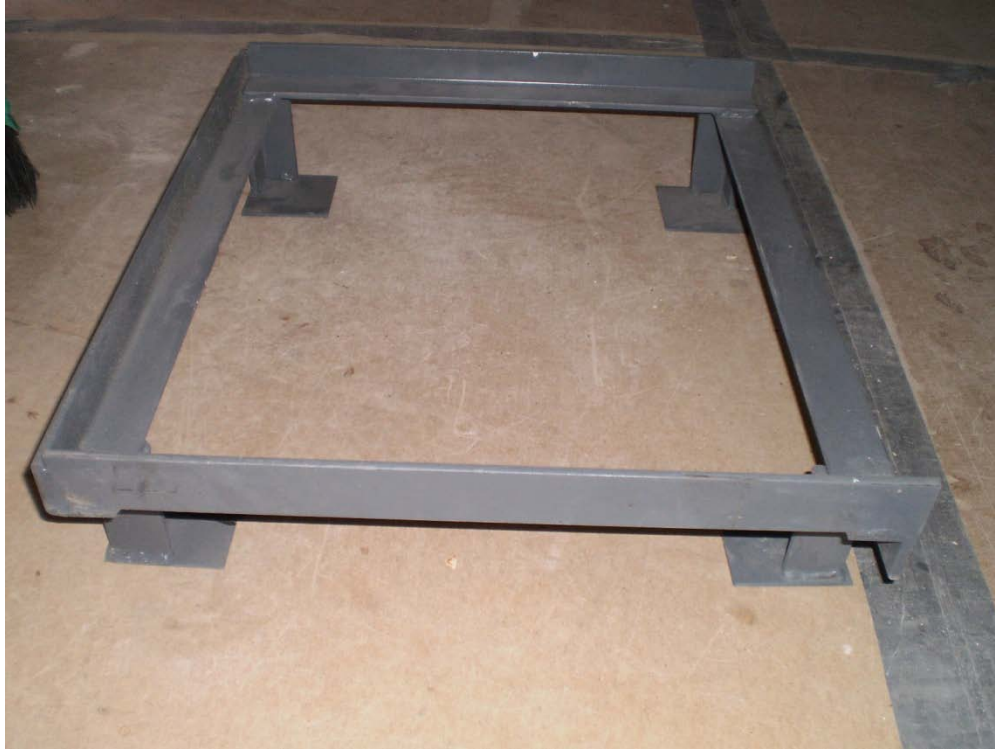
At left, close-up of newly installed valves and newly installed pipe insulation (white & black in color).

Installation of new HVAC unit – Once the fire stopping and insulation is complete the stand for the new HVAC unit is installed (photo immediately below). The stand is necessary to ensure that the unit fits in the space going over and not interfering with riser clamp, which would cause the unit to stick out into the room too far.

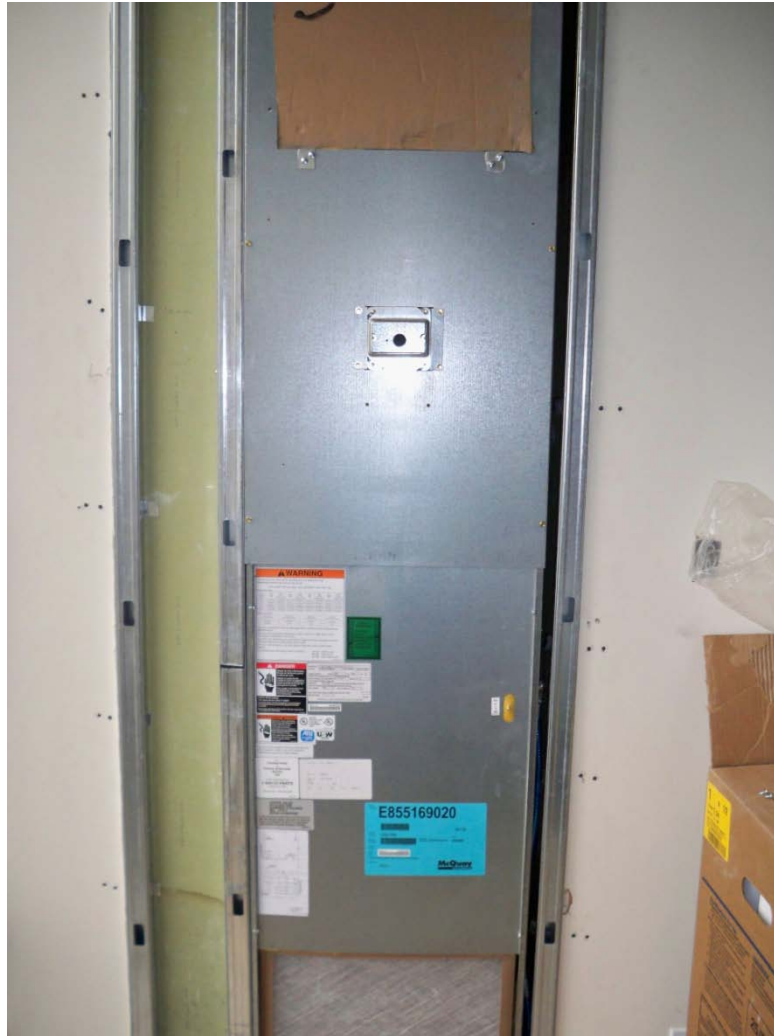
Installation of new HVAC unit (continued) – The photo below shows a new HVAC unit installed into properly prepared space. Part of the installation process requires the contractor to have an air and water balancer complete performance tests on the HVAC unit to ensure that it is operating per its design specifications.

Restoration – Once the HVAC unit is installed, the contractor must start the wall restoration process. In the photo above, the contractor has already framed around the new HVAC unit and installed new sheetrock/wallboard. The next step in restoration is taping, spackling, priming, finish coat paint and/or installation of any other custom finishes.

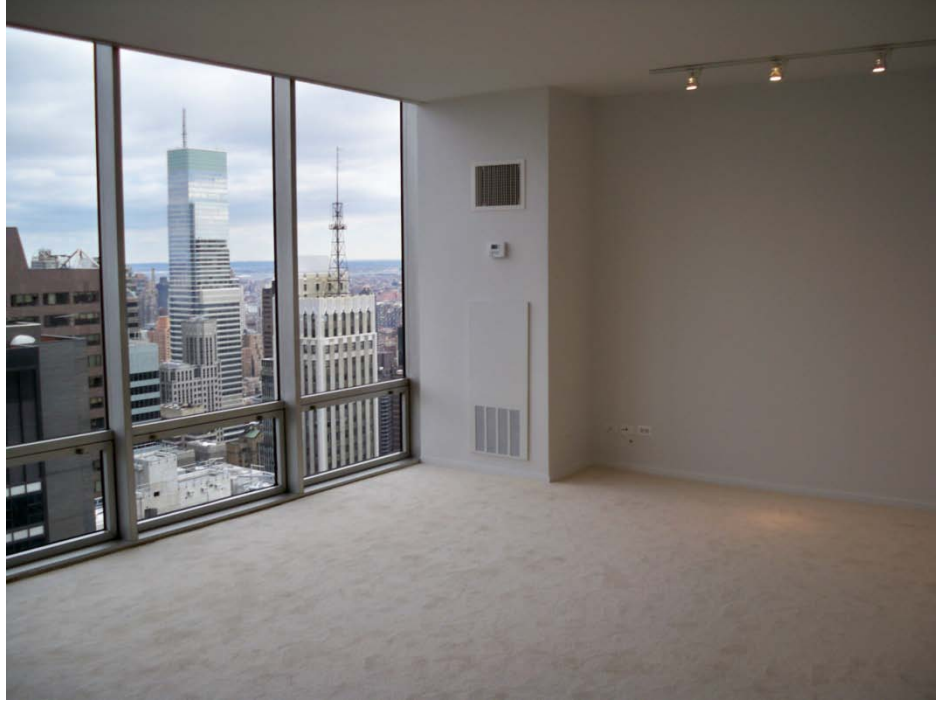
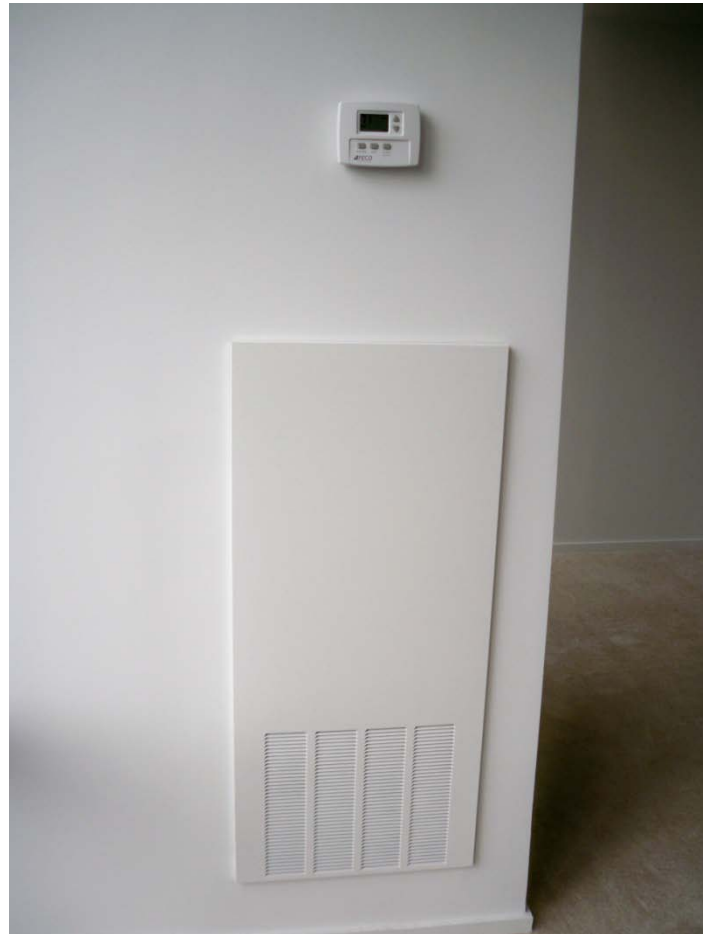
Project Completed – When the contractor removes the protection in the apartment, you are ready to enjoy a brand new, efficient, quiet, state-of-the-art HVAC unit that has stainless steel condensate pans, leak sensors and a programmable thermostat (see photos below).
